Architectural Documentation of  
**Oratorian - Influenced  
Missionary Churches**  
in Sri Lanka

# Architectural Documentation of **Oratorian - Influenced Missionary Churches** in Sri Lanka

# St. Joseph's Church Kanthankulam

01. Ref. No  
ADOC17/MN/02

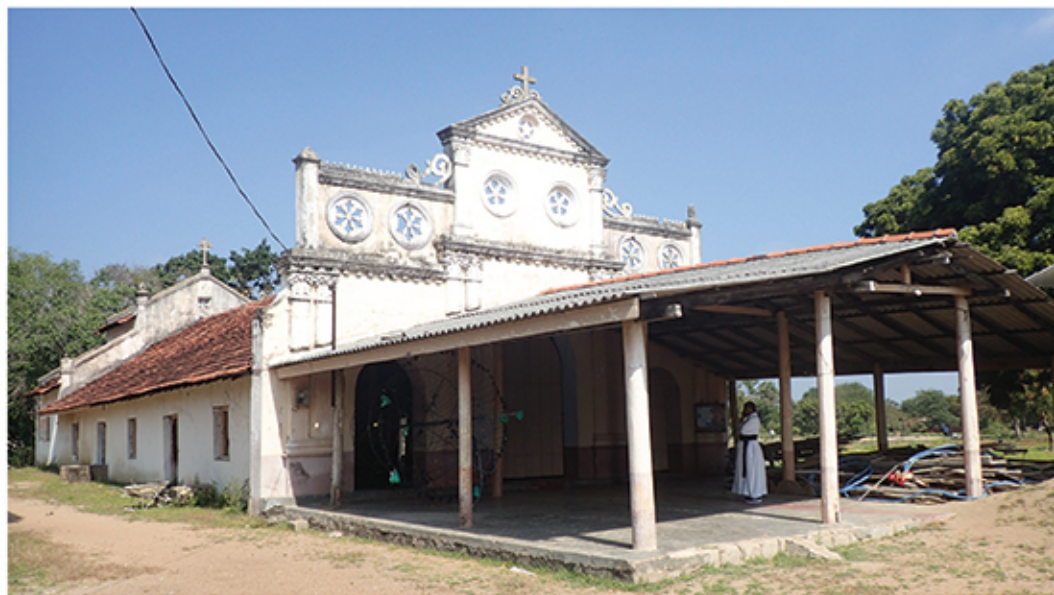
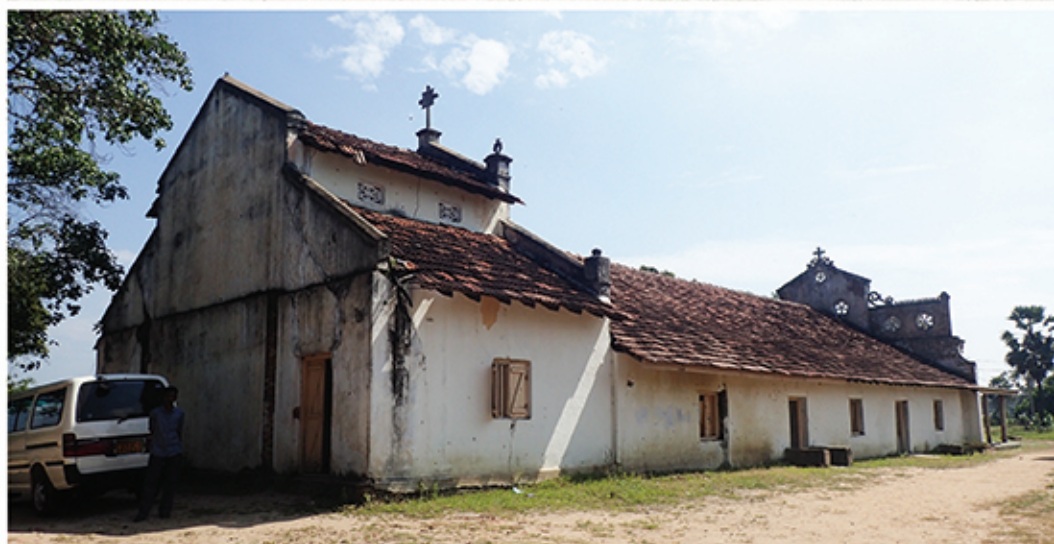
## 04. Photographic Study / Exterior

Most of the details of architectural interest lie in its nave and two aisles. The aisles that evolved within this church facilitated the placement of two symmetrical arches on either side of the triumphal arch to make a passage to the lateral chancels.

A temporary structure has been erected at the entrance.

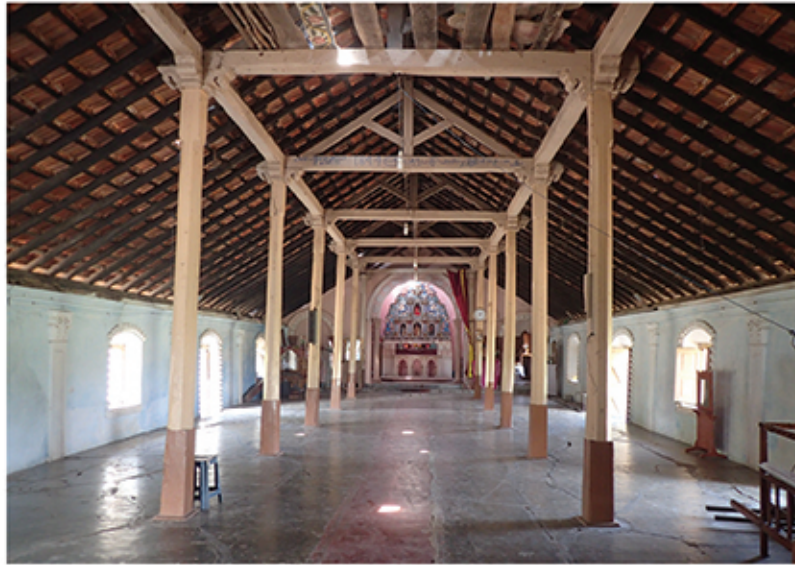
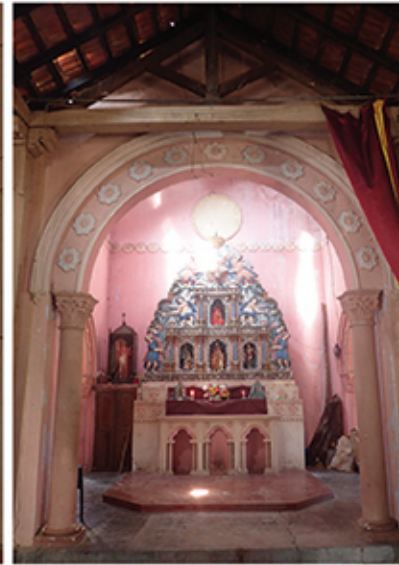
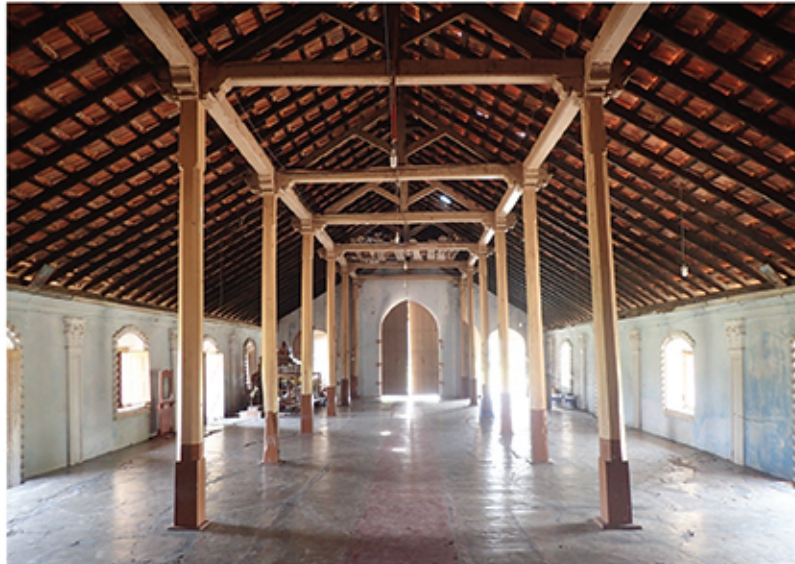
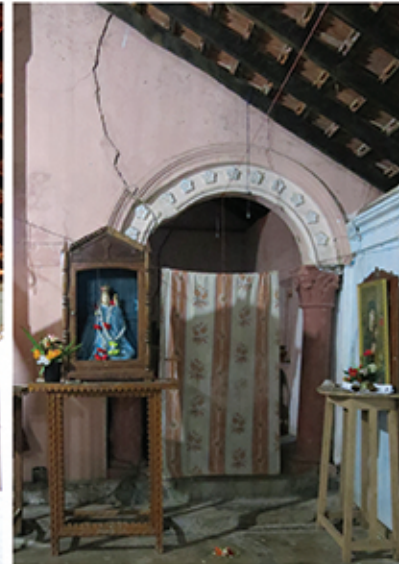
## 05. Photographic Study / Interior

The wall behind the altar has an elaborated masonry retable decorated with local motifs. Overall structure is in a very dilapidated state due to lack of maintenance during last decades.
